ASDE-2 TRANSMITTER MODIFICATIONS

Federal Aviation Administration

REPORT NO. FAA-RD-72-32

SEPTEMBER 1972  
FINAL REPORT

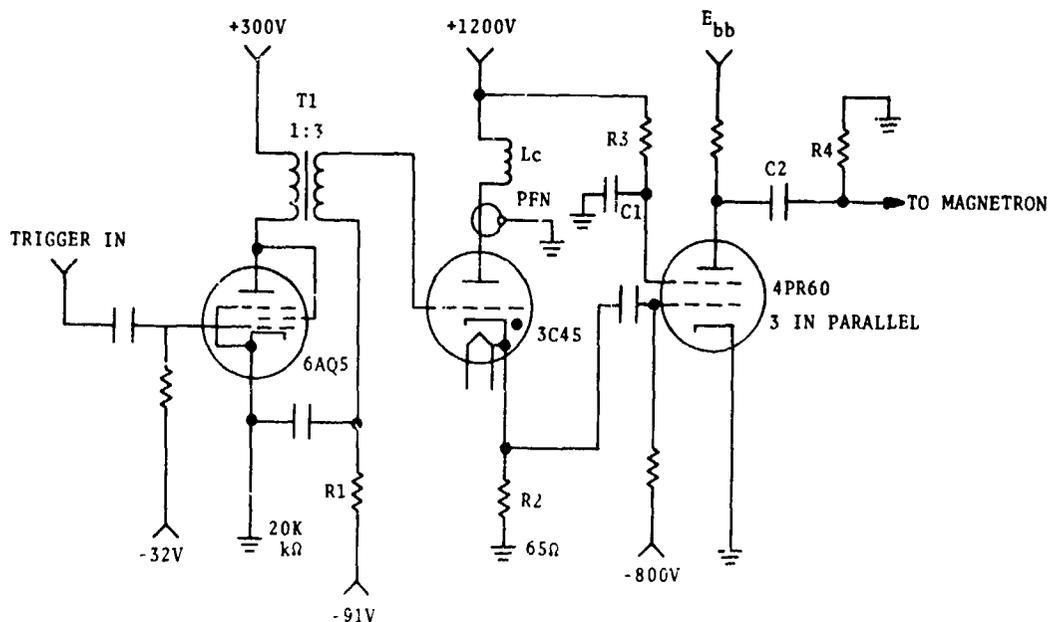
Figure 2. Simplified Modulator Schematic

The hydrogen thyatron type 3C45 is a very poor choice for the modulator driver. Life tests on this tube have shown that it will not survive for long at high pulse rates.<sup>1,2</sup> In addition the radar circuit of which it is a part (Figure 2) is not well matched to its operating characteristics. For example, the stray capacitance that the 3C45 must charge during each pulse was measured and found to be 240 pico-farads, of which 80 pF is attributed to the filament transformer. The peak current required to charge this capacity is calculated to be about 24 amperes. The parallel load provided by the thyatron cathode resistor and the grid input circuit of the 4PR60 tubes is about 65 ohms at 1000 volts, leading to a resistive current component of 15 amperes. Thus, the 3C45 is required to deliver nearly 40 amperes peak when its rated maximum capacity is 35 amperes.

Attention is directed to Figure 2 and to the 65 ohm total resistance in the cathode of the 3C45. The reflected value of  $R_2$  is now 50 ohms in the modified driver, which is a proper match for the pulse forming network made up of 8 feet of 50 ohm RG-8/U coaxial cable. An impedance match is most necessary if the output pulse is to return quickly to zero, a condition that is important when operating at a high PRR. The pulse appearing across the 50 $\Omega$  resistance coupled to the 4PR60's is 1150 volts positive when the driver is an 8765 and only about 1050 volts with a new 3C45 (see Figure 5). Thus, the 8765 drives the 4PR60's 350 volts positive compared to 250 volts for a 3C45. Some of the latter tubes could not drive the 4PR60's into the positive grid region at all, which resulted in very short tube life due to cathode contamination.

Since one 4PR60 is capable of delivering 20 amperes, a first thought is, why use 3 tubes in parallel when one will suffice. However, one tube will not supply enough current, because of the ever present distributed capacitance and also because of the current drawn by a 2000 ohm resistor (R4 in Fig. 2) which is required for recharging the magnetron coupling capacitor. The current through this resistor (if the inductance is neglected) is:

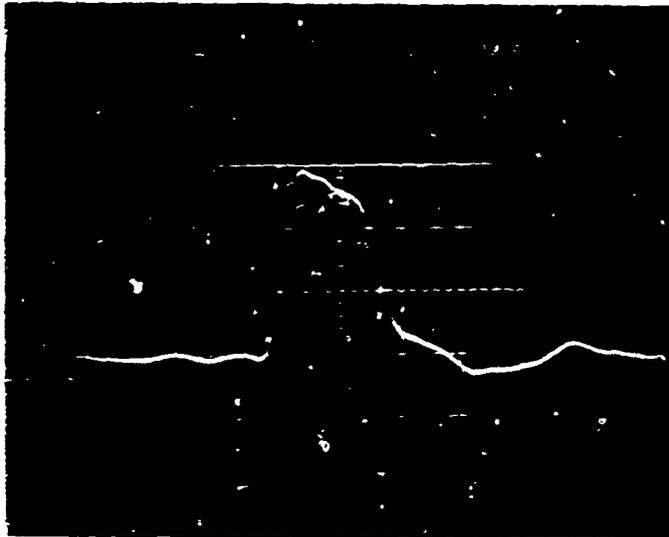
1. Sweep - 10ns/cm
2. This is a sample RF pulse taken from a crystal rectifier mounted in the wave guide.
3. The magnetron peak power was 39kW.

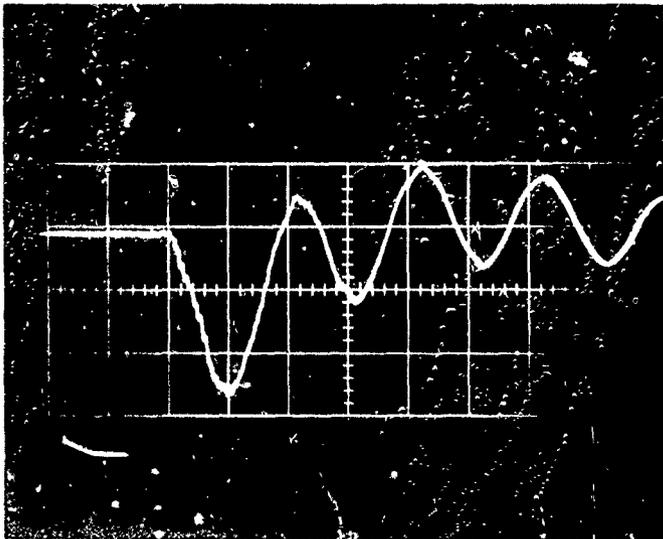
Figure 10. Magnetron Voltage Pulse with a Very Low Inductance Capacitor

A low inductance capacitor (0.2 $\mu$ H) was installed with mixed results. The ringing frequency was increased accordingly and the double pulsing was reduced but not completely eliminated. Figure 10 shows the magnetron voltage pulse with a 2000pF, low-inductance capacitor. Double pulsing was produced simply by adjusting the magnetron voltage. Figure 11 shows the magnetron voltage pulse with a 5000pF, 32 $\mu$ H capacitor. Strangely enough, double pulsing could not be produced even though the second pulse is quite pronounced. This is due to the fact that the height of the second pulse is not sufficient to turn the magnetron on.

Sweep 50 ns/cm  
 Voltage 5kV/cm  
 $L_s = 0.2\mu\text{H}$
